Swab Mob! Using Adenosine Triphosphate screening to improve environmental cleaning practice in residential care settings during COVID-19.

SJOG Research Series

May 2021

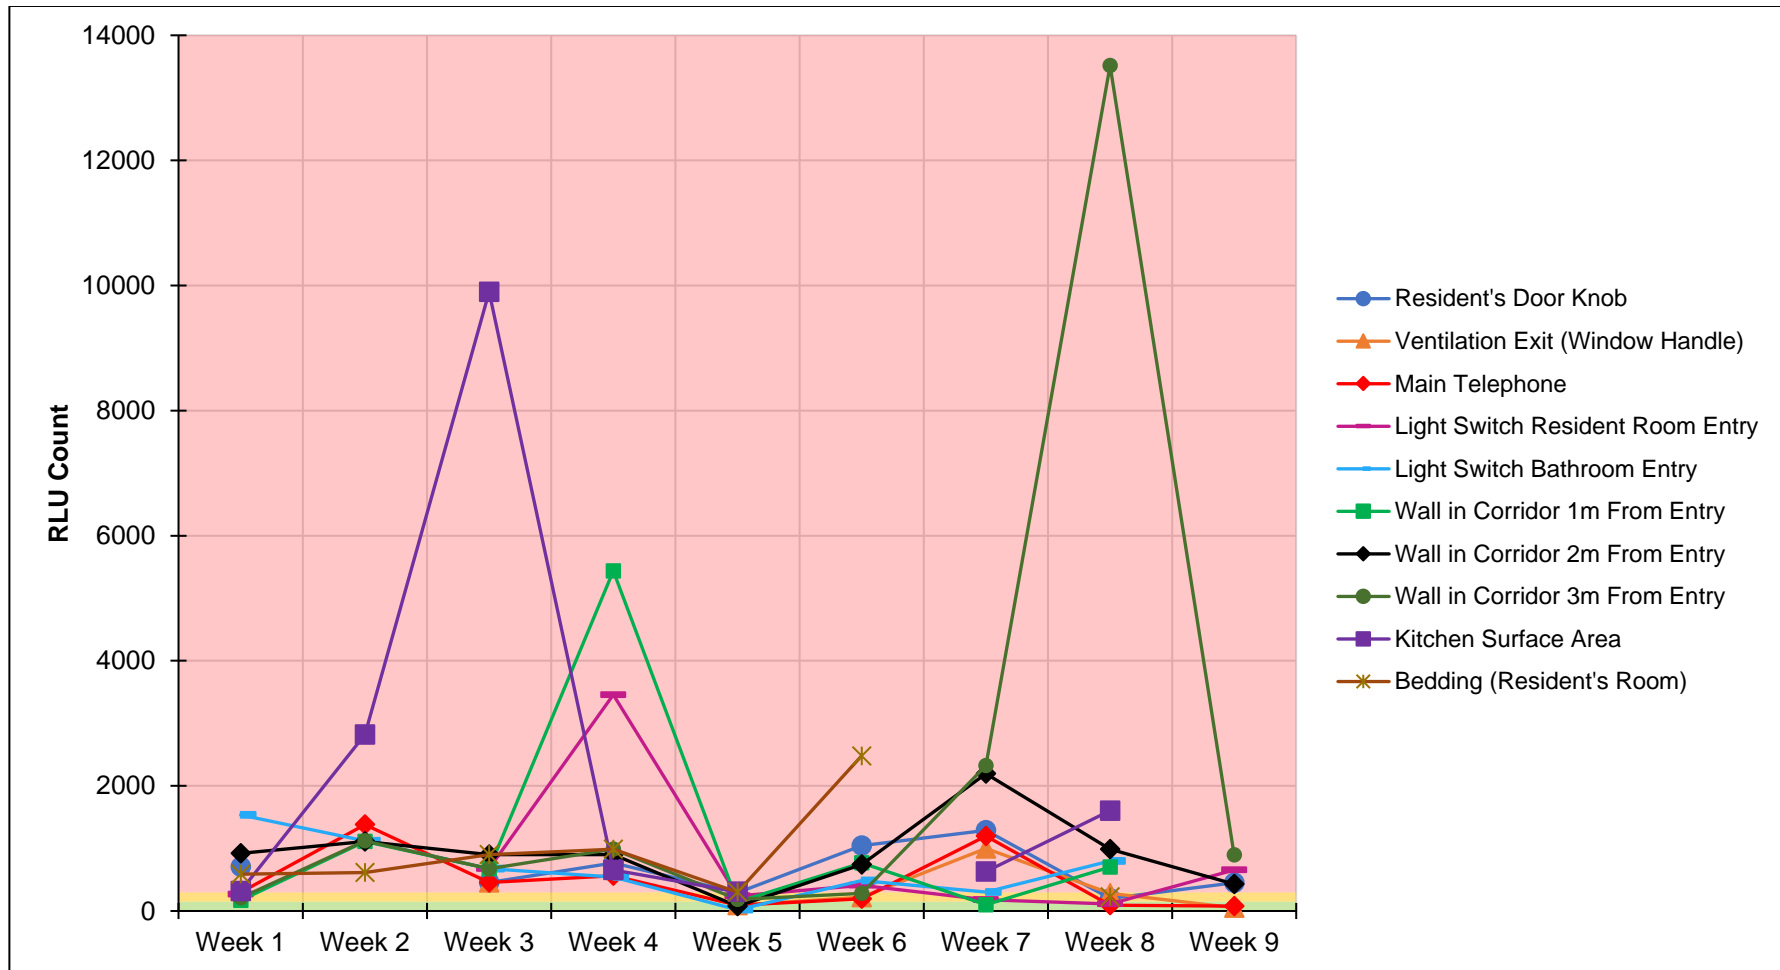
Figure 2. Findings from 10 swabbed surfaces at Sandown Road over a nine-week period. Note the Red, Amber, Green (RAG) rating limits.

Each of the 10 nominated surfaces recorded a "red" swab at least twice over the nine sessions. Seven surfaces (resident's door knob, ventilation exit, main telephone, light switch resident room entry, wall in corridor 1m from entry, wall in corridor 3m from entry, and bedding) recorded an "amber" swab at least once. A further six surfaces (ventilation exit, main telephone, light switch resident room entry, light switch bathroom entry, wall in corridor 1m from entry, and wall in corridor 2m from entry) recorded a "green" swab on at least one occasion (see Figure 2).

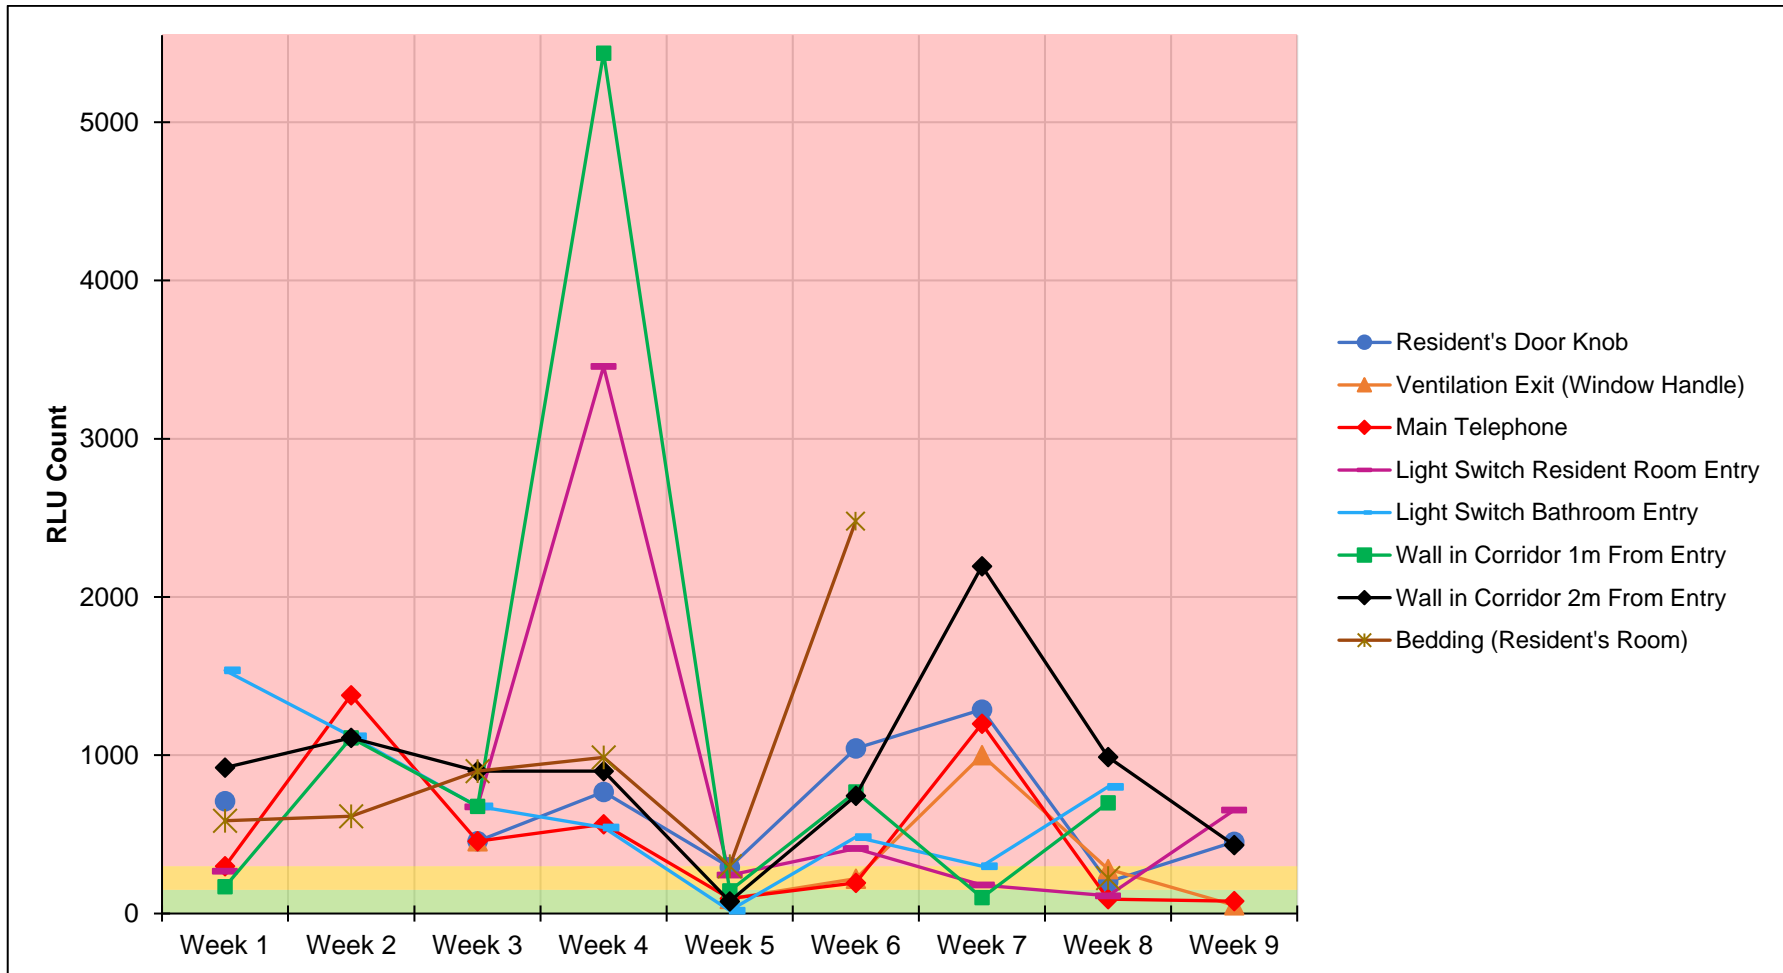
Figure 3. Findings from eight swabbed surfaces at Sandown Road (wall in corridor 3m from entry and kitchen surface area removed) over a nine-week period. Note the Red, Amber, Green (RAG) rating limits.

The kitchen surface area and the wall in the corridor 3m from entry recorded much higher values on week 3 and week 8, respectively. As a result, these two surfaces were removed from Figure 3 in order to better see trends in the other surface data.

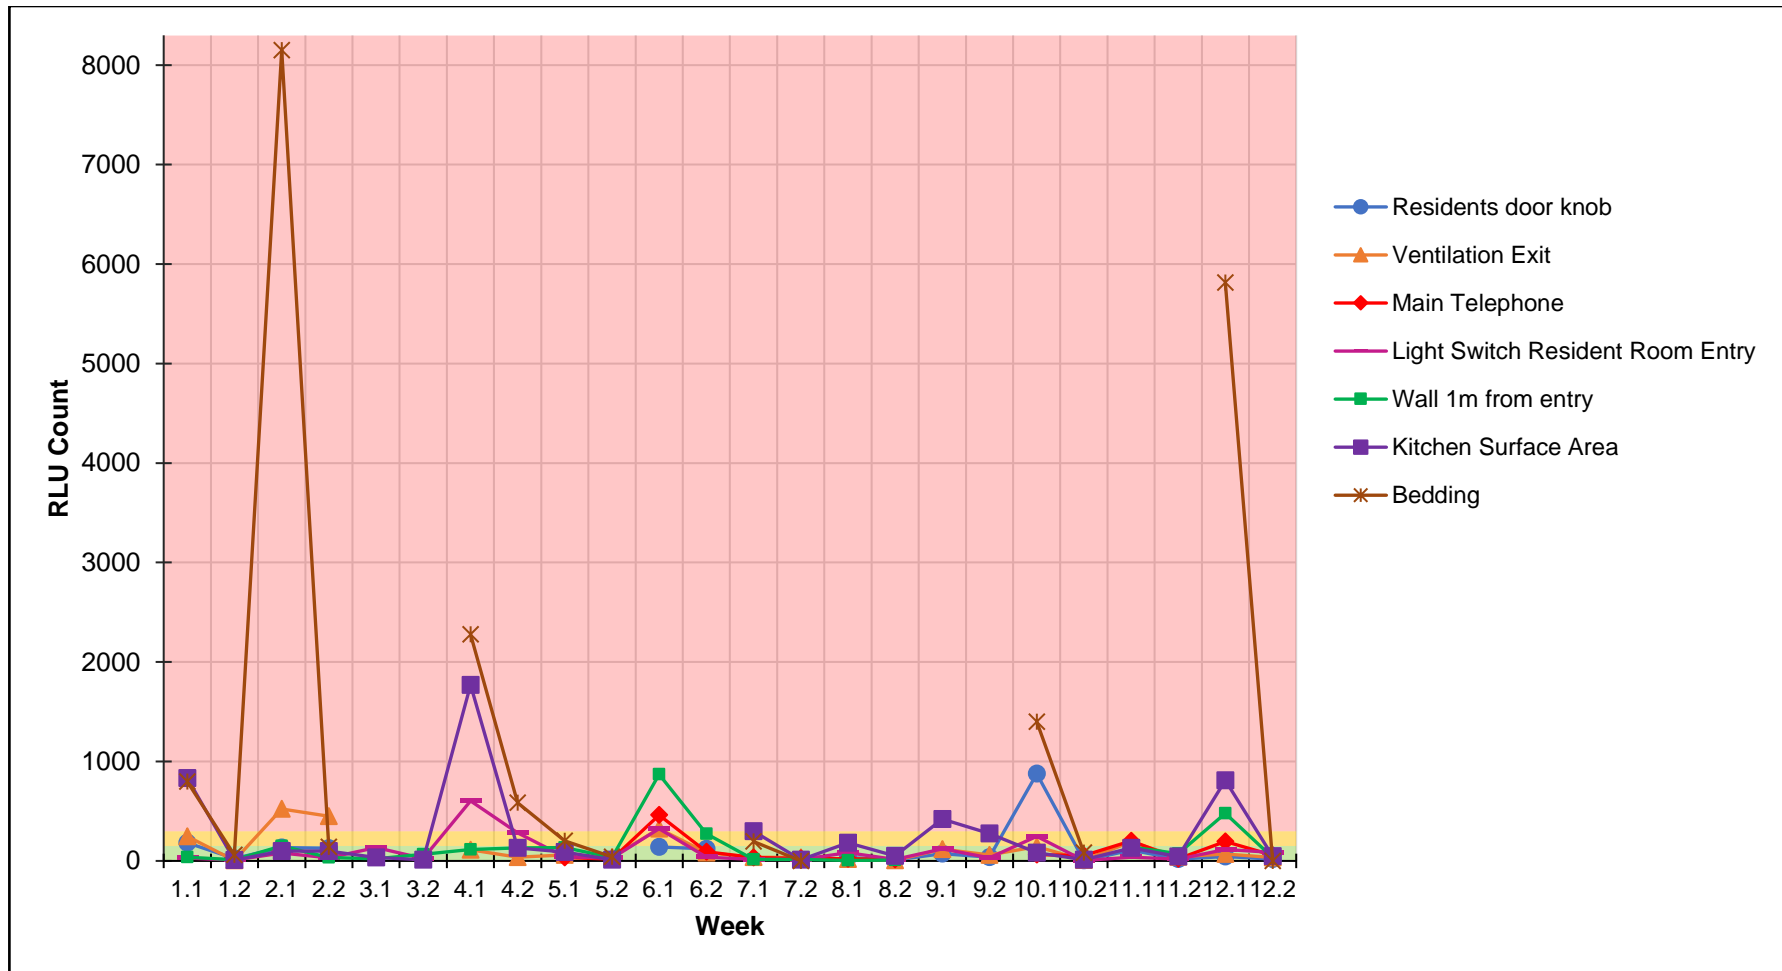
Figure 4. Findings from seven swabbed surfaces at NSL over a 12-week period. Note the Red, Amber, and Green (RAG) rating limits.

Each nominated surface recorded both a "red" and "amber" reading at least once over the 12 weeks (see Figure 4). Excluding bedding (which recorded a "green" reading on 6 out of the 14 times it was swabbed) all nominated surfaces reported "green" on most recorded swabs.

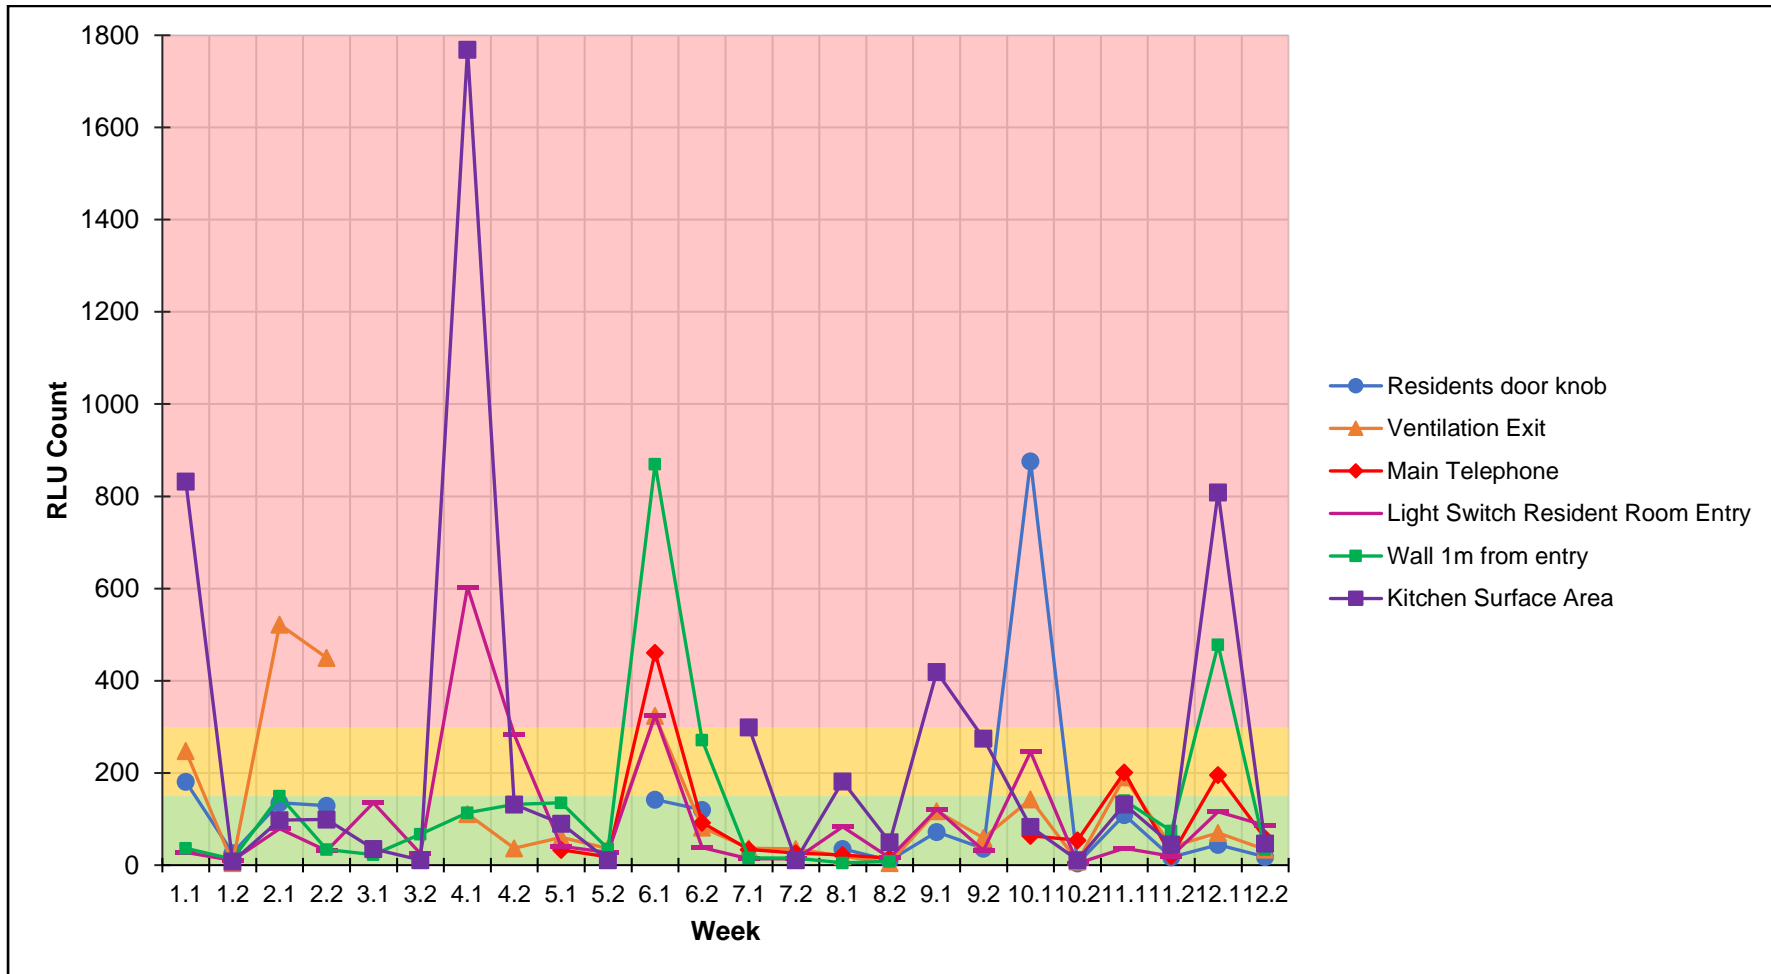
Figure 5. Findings from six swabbed surfaces at NSL (bedding removed) over a 12-week period. Note the Red, Amber, and Green (RAG) rating limits.

As bedding recorded much higher results on weeks 2, 5, and 12 it has been removed from Figure 5 to show the results from the other reported surfaces more clearly.

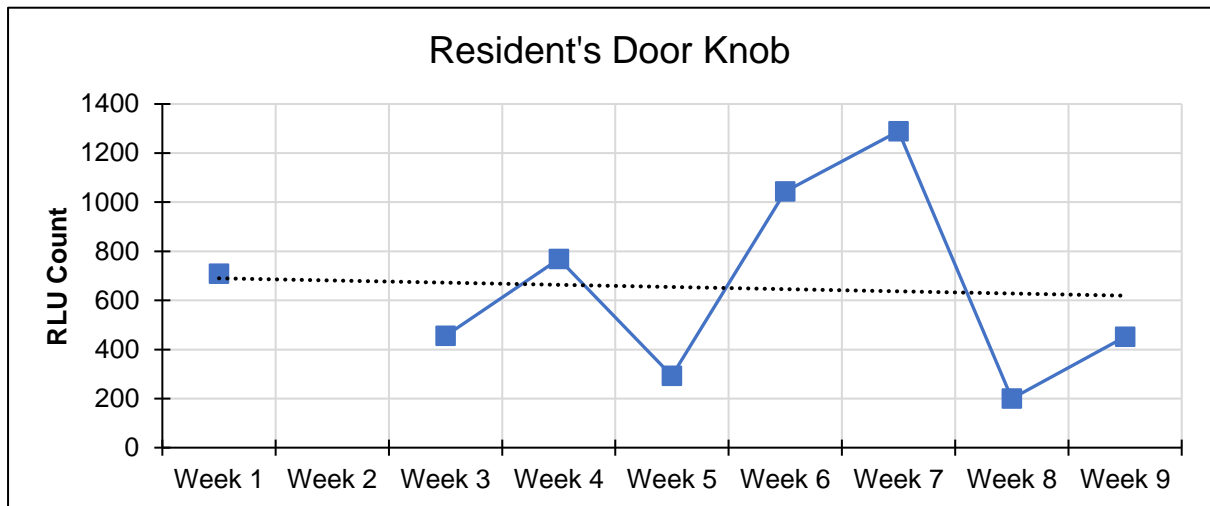
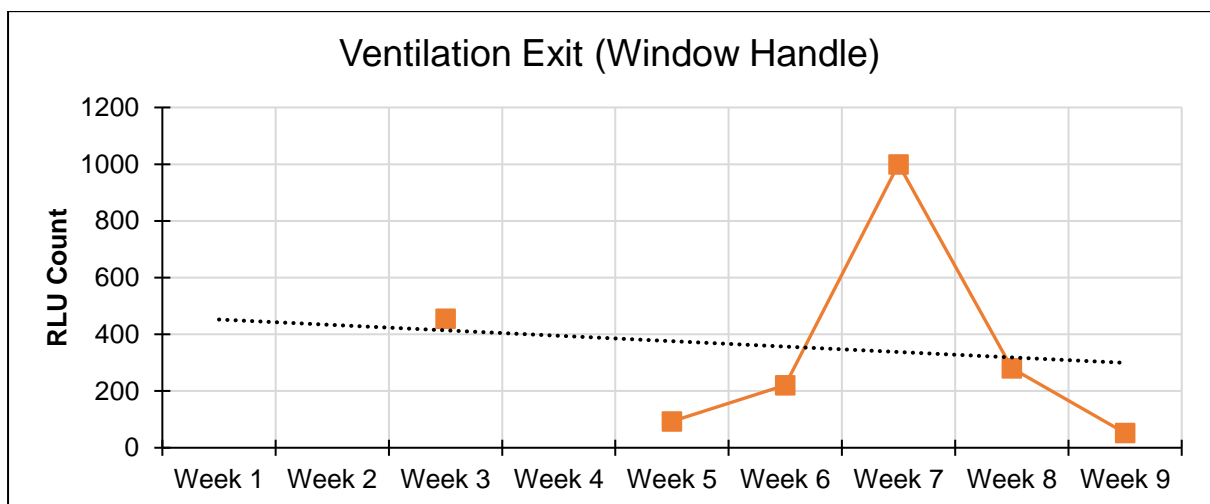
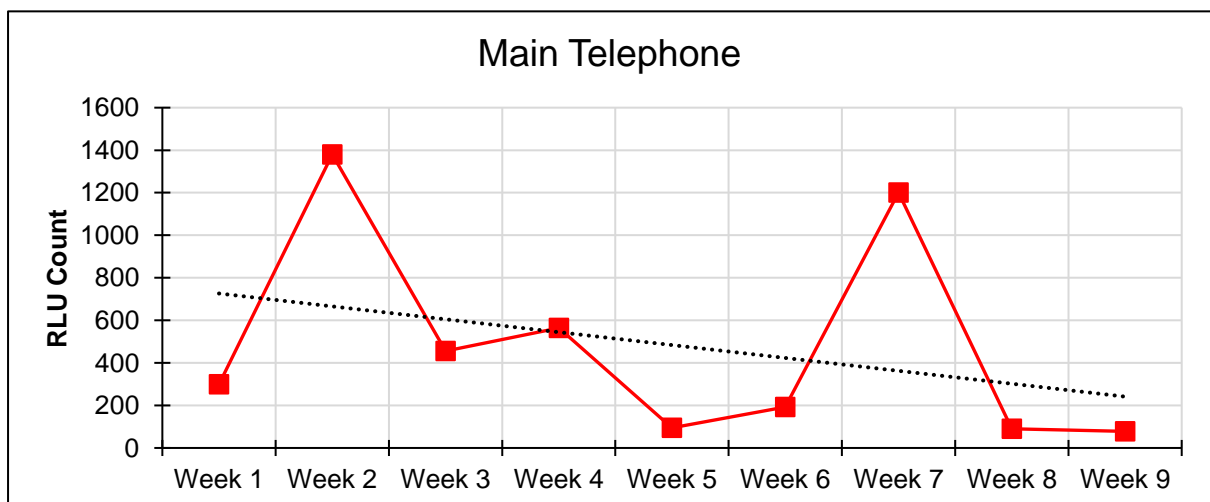
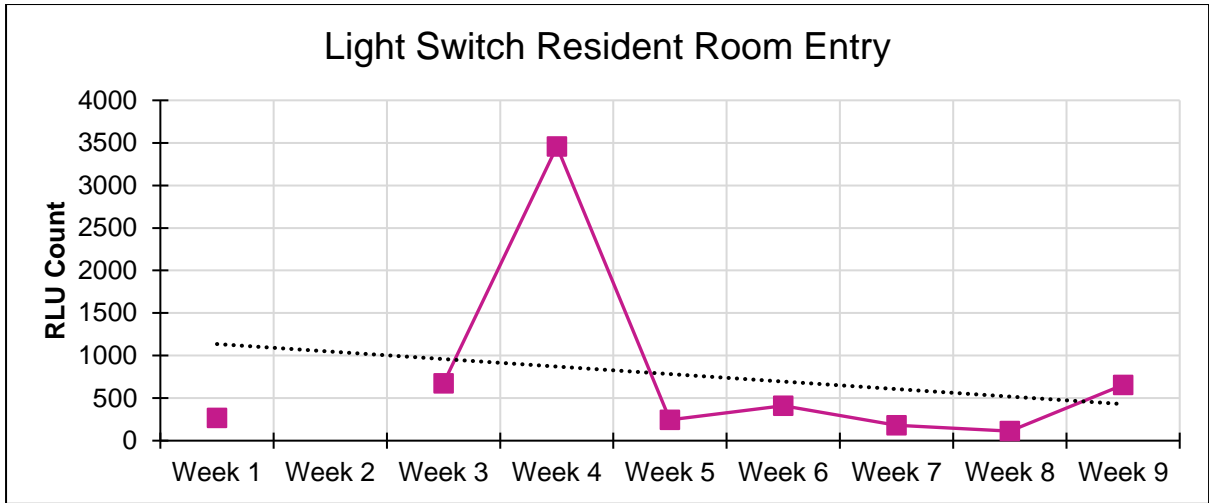
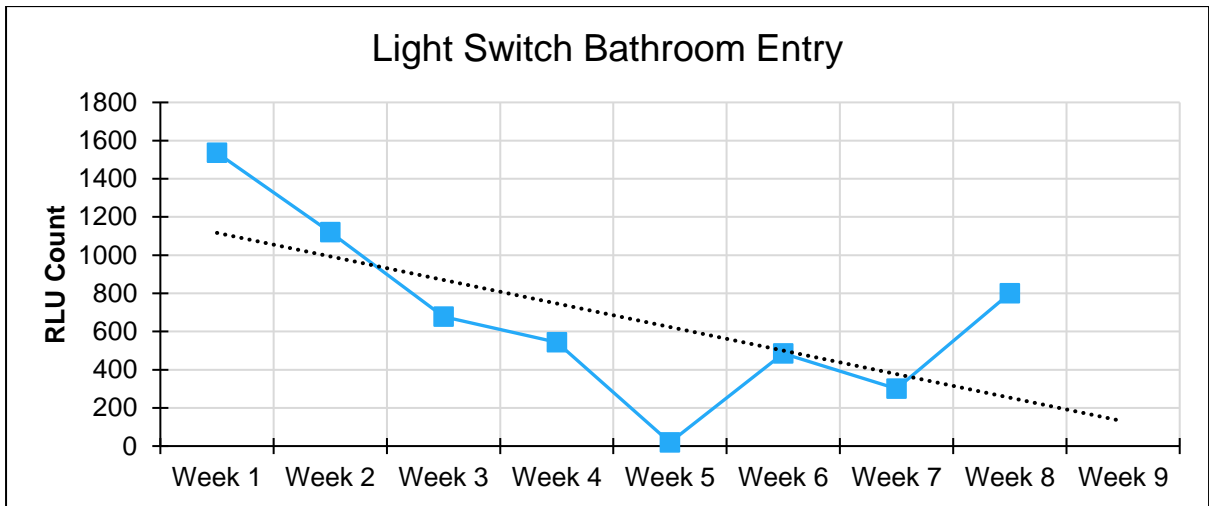
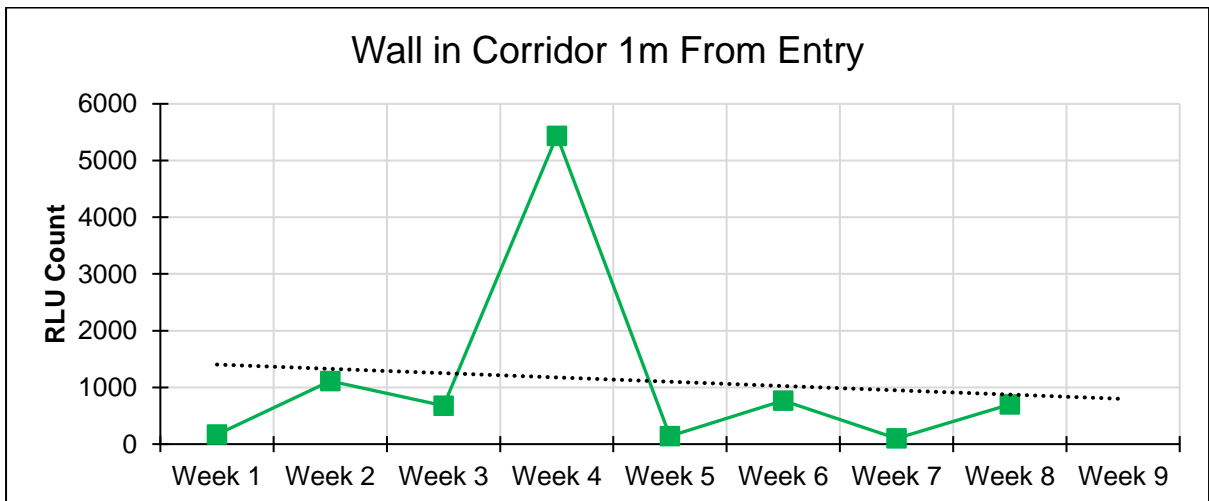
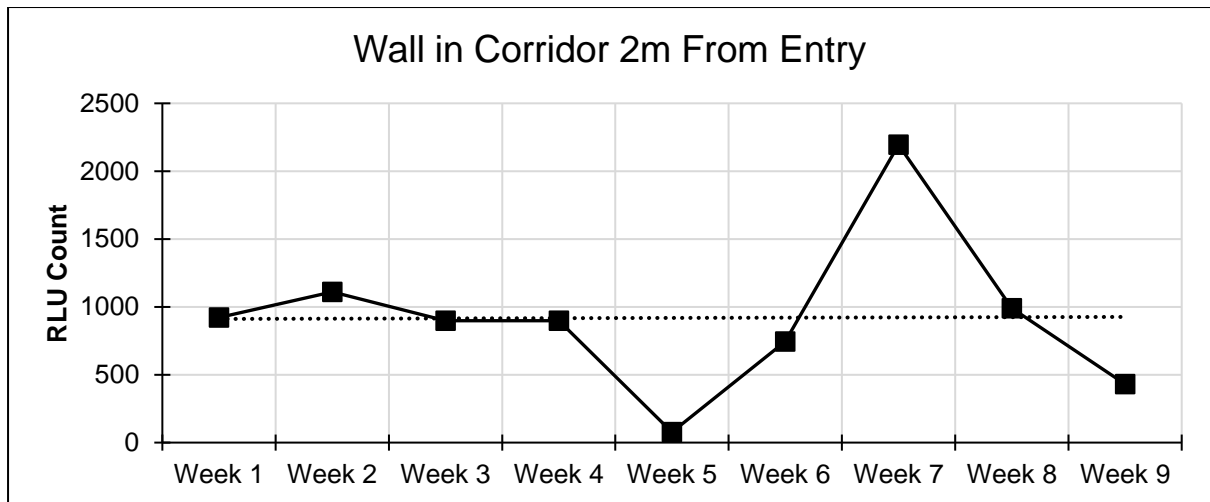
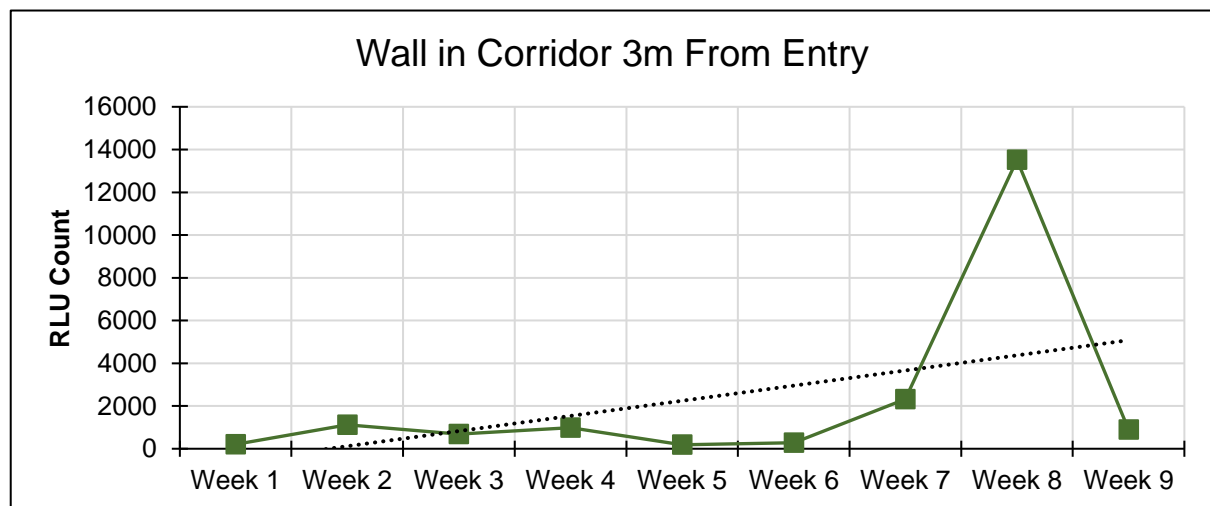
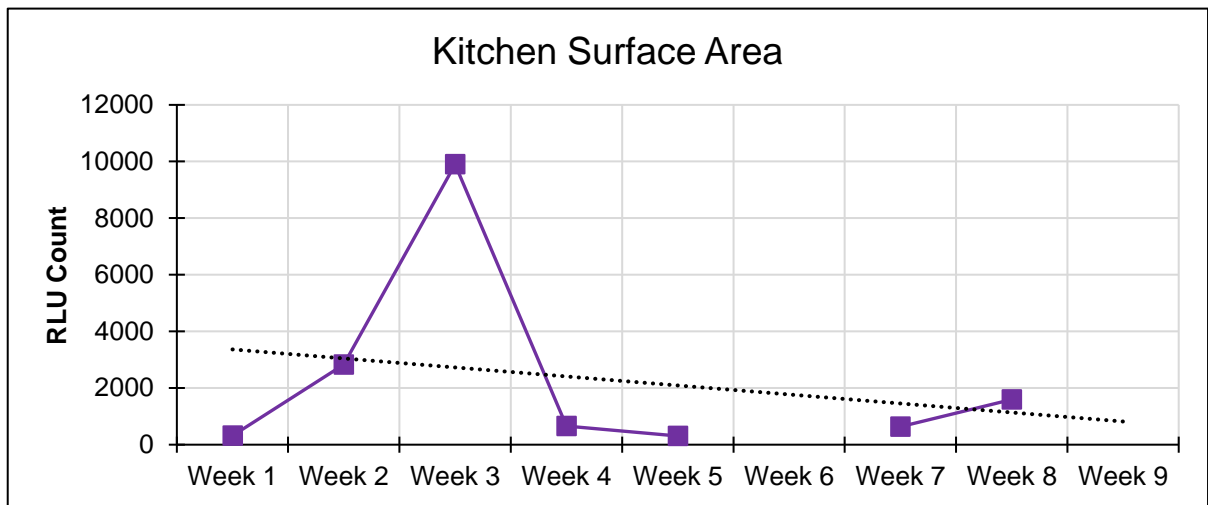
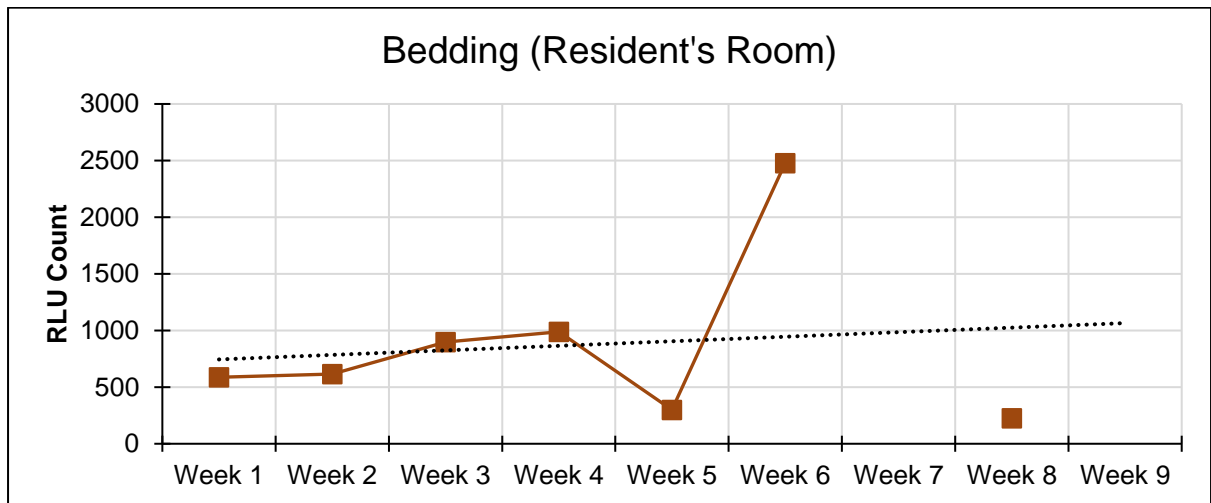
Appendix 1: Individual surface RLU counts across a nine-week swabbing period at Sandown Road.

The wall in the corridor 3m from entry showed an increase in surface contamination. In particular on week 8 where it returned an RLU count of 13516. This may have been a human error, but it also must be noted that it is a high-touch surface.

Surface contamination of the resident's bedding increased over the nine-week period. However, as bedding is predominately contaminated by an individual's normal body flora there is a lower risk of transmission and adverse health effects.

All but three of the 10 nominated surfaces demonstrated an overall decrease in surface contamination over the swabbing period, whilst the wall in the corridor 3m from entry and resident's bedding both showed an increase in surface contamination. The wall in the corridor 2m from entry saw no change (see Appendix 1).

1. Findings from the individual surface RLU counts (see Appendix 1) inferred a downward trend in surface contamination at touchpoints. For example, while 7 touchpoints displayed a decrease in surface contamination over the project period, the wall in the corridor 2m from entry and the wall in the corridor 3m from entry saw either no change or an increase in contamination, respectively. This implies that these areas are overlooked during cleaning activities as they may not be viewed as typically dirty surfaces but may be reservoirs of transmission.

2. Surface contamination of the resident's bedding also increased over the nine-week period (see Appendix 1). However, as bedding is predominately contaminated by an individual's normal body flora (Fallon, 2017) there is a lower risk of transmission and adverse health effects compared to surfaces that multiple people come into contact with. Therefore, although the ATP may infer high contamination, bedding is still frequently washed and is of low risk.

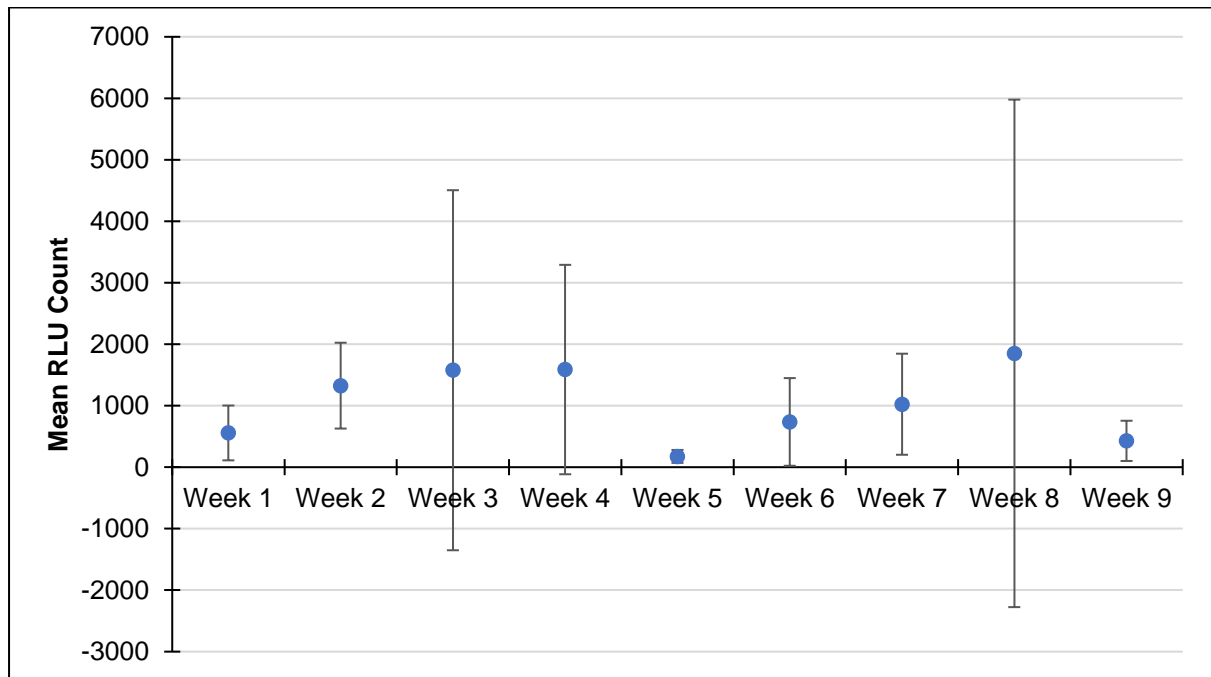
Appendix 2: Mean RLU count with standard deviation error bars (Sandown Road).

The mean RLU count for each week was calculated along with standard deviation error bars (see Appendix 2).

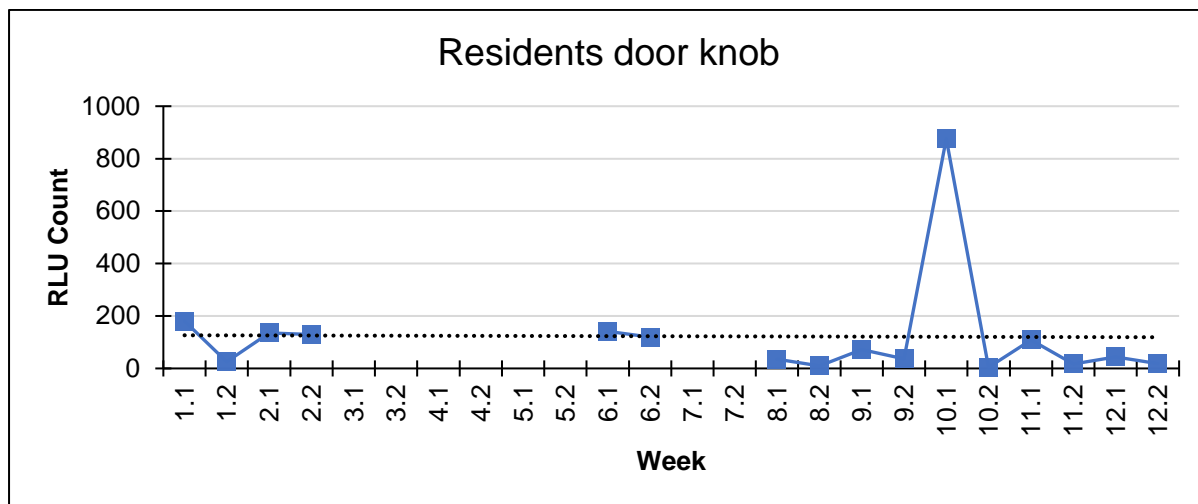
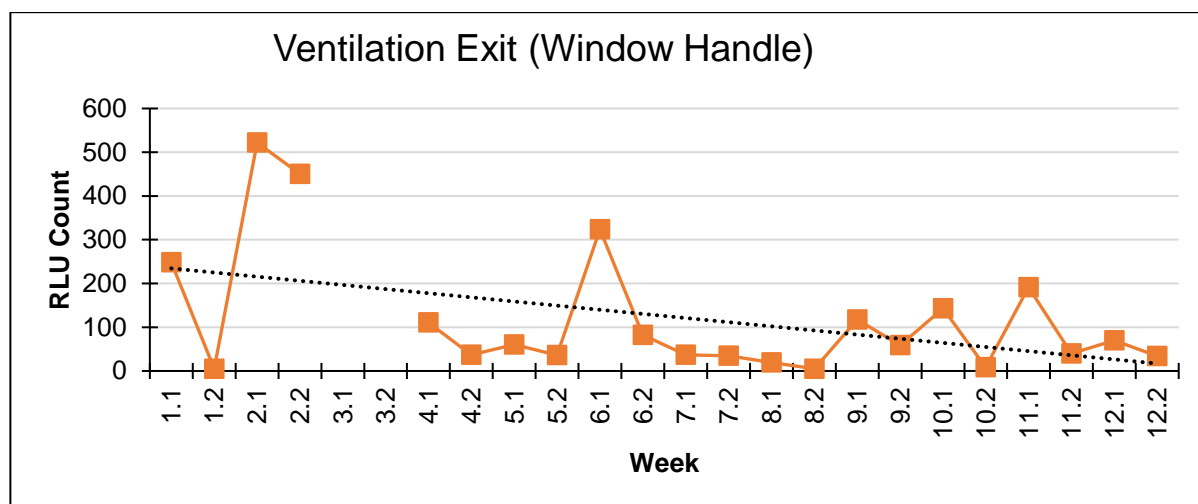
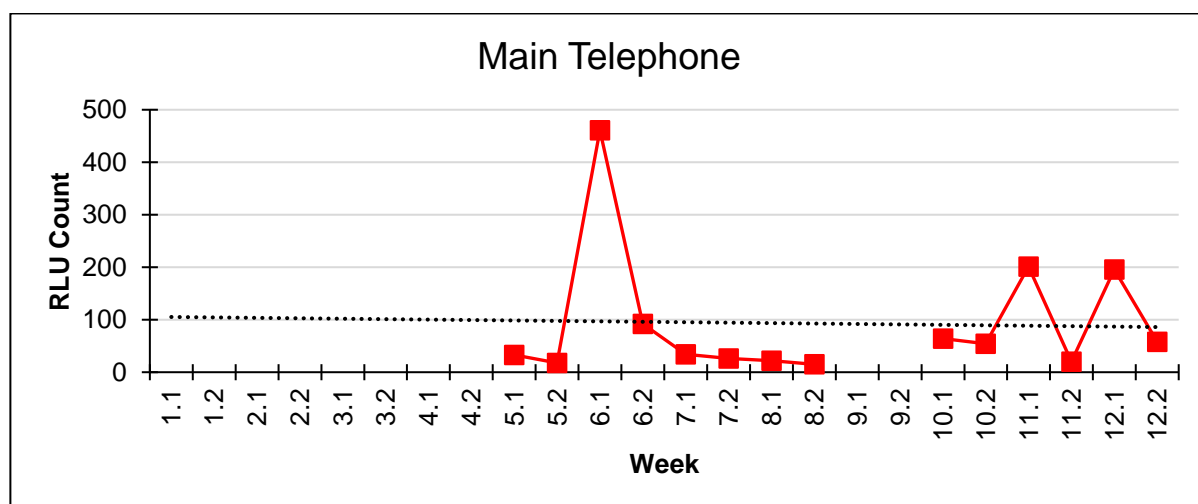
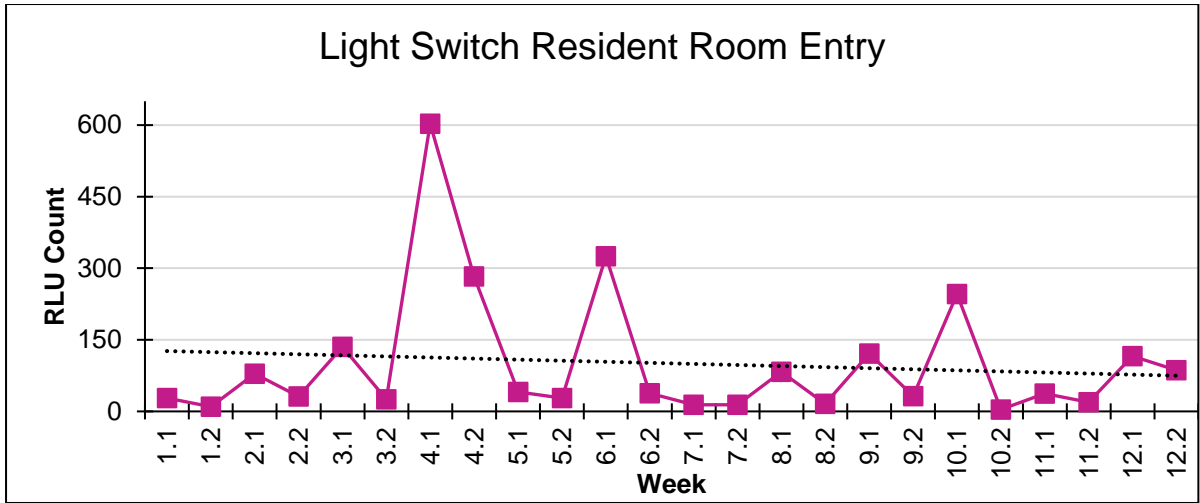
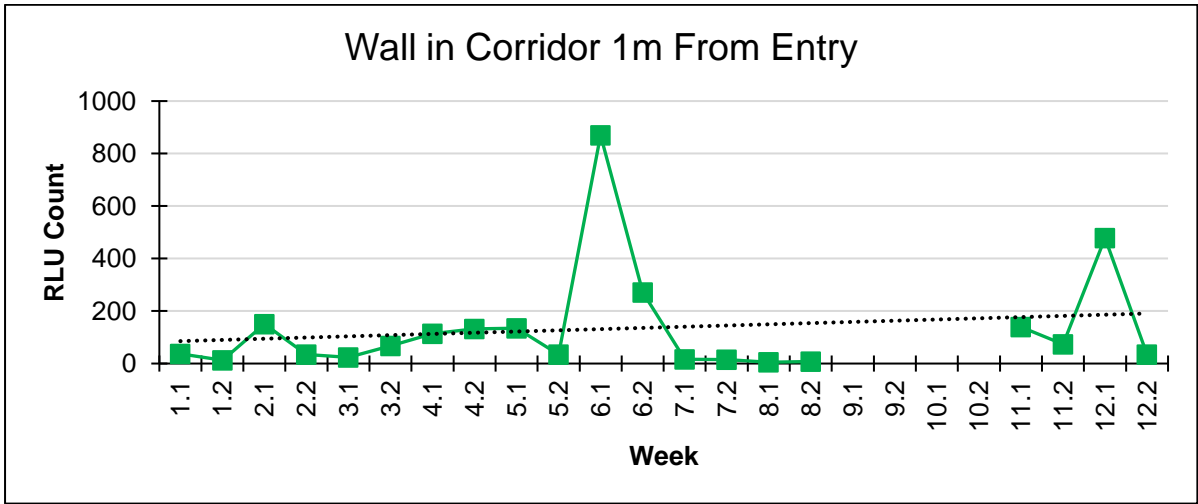
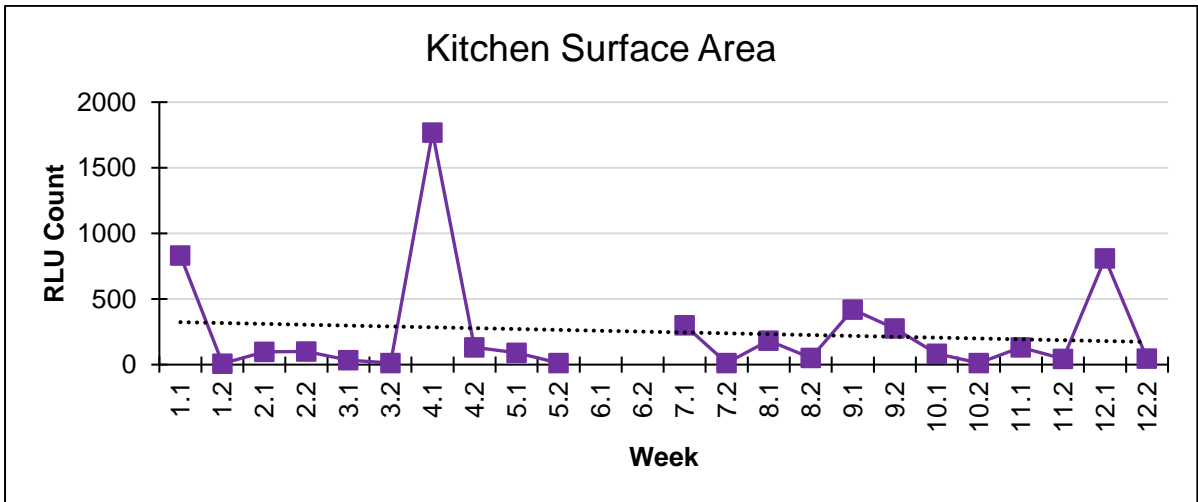
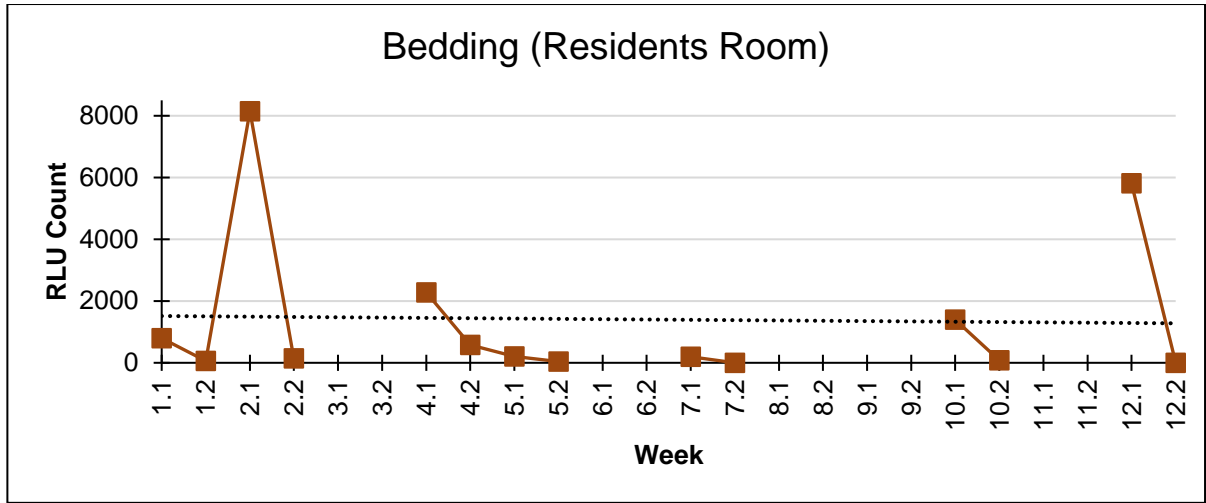
Appendix 3: Individual surface RLU counts across a 12-week swabbing period at NSL.

Six out of the seven nominated surfaces illustrated an overall decrease in surface contamination over the swabbing period. Whereas the wall in the corridor 1m from entry showed an increase in surface contamination.

1. Findings from the individual surface RLU counts (see Appendix 3) showed an overall downward trend in surface contamination at touchpoints. Whereas surface contamination increased for wall 1m from entry implying areas that are not directly touched may be neglected when cleaning, possibly not being viewed as dirty surfaces.

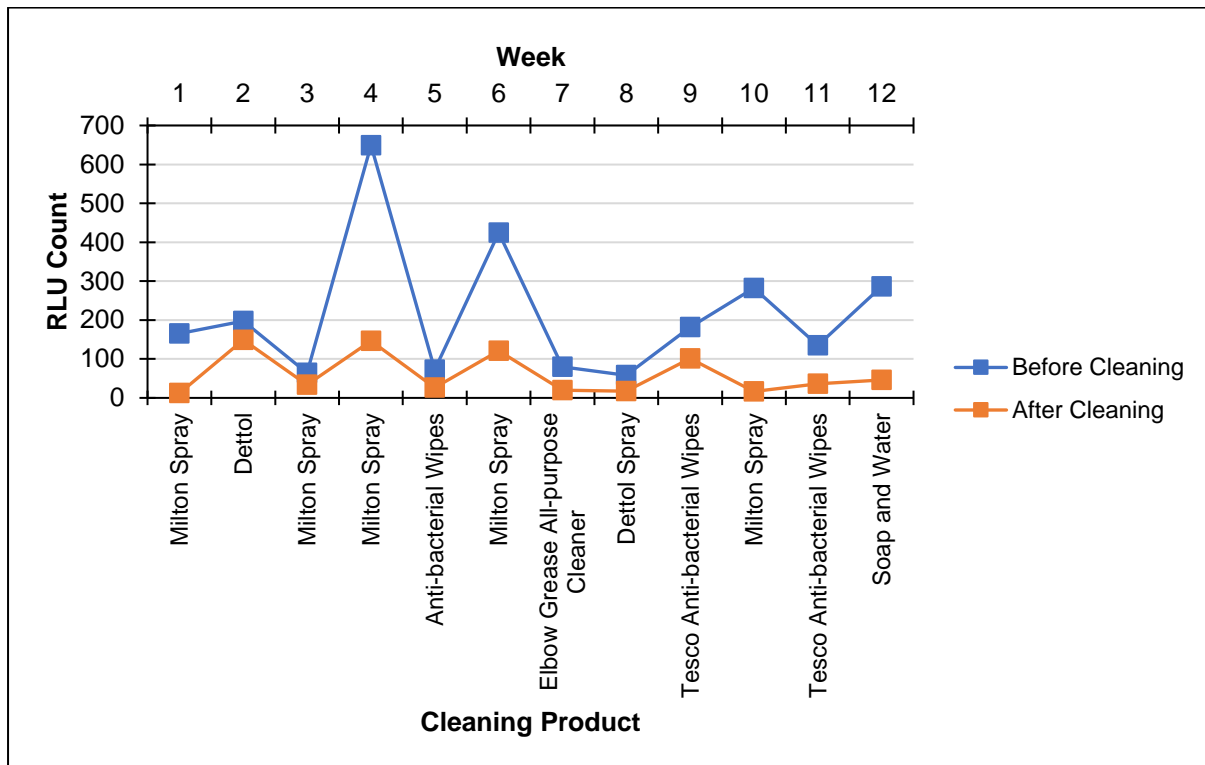
Appendix 4: Mean RLU count before cleaning and after cleaning along with the cleaning product used.

While “before cleaning” counts were inconsistent it can be seen that Milton anti-bacterial spray and soap and water are shown to cause the biggest decrease in RLU whereas the use of popular brands such as Dettol and Tesco made little difference to contaminant levels.

Colleagues at the NSL services took it upon themselves to record their method of cleaning each week. Colleagues found that using the ATP testing allowed them to evaluate their own methods of cleaning. For example, they found that scrubbing with soap and water or Milton Anti-bacterial Spray was more effective at getting rid of surface contaminants over various other brands of anti-bacterial spray and wipes (see Appendix 4).

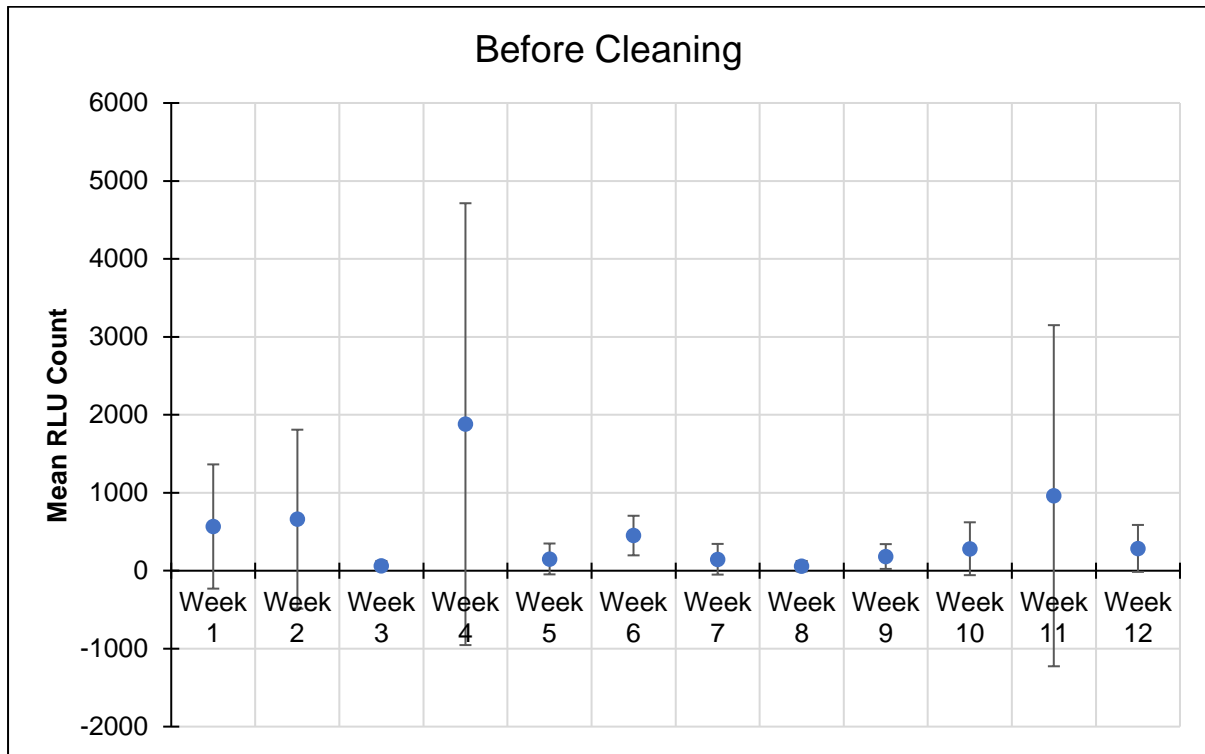
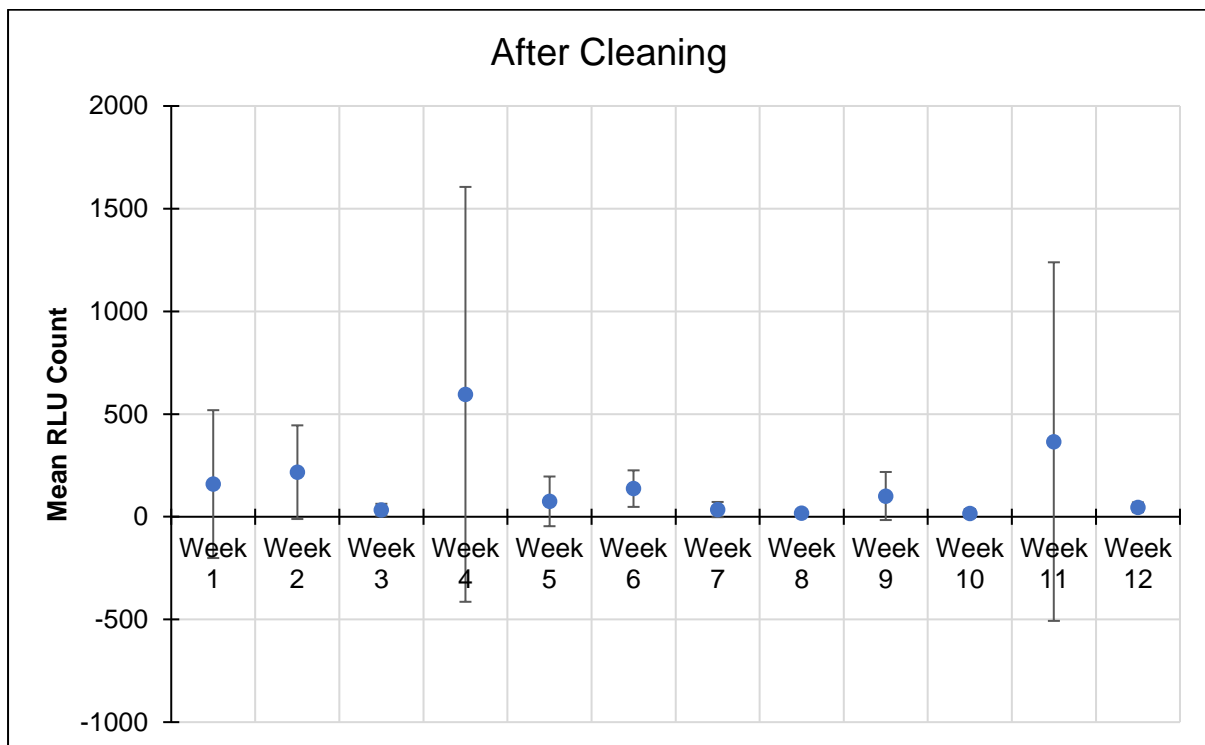
Appendix 5: Mean RLU count with standard deviation error bars (NSL).

The mean and standard deviation of the RLU count before and after cleaning were calculated for each week, (see Appendix 5).
