Swab Mob! Using Adenosine Triphosphate screening to improve environmental cleaning practice in residential care settings during COVID-19.

SJOG Research Series

May 2021

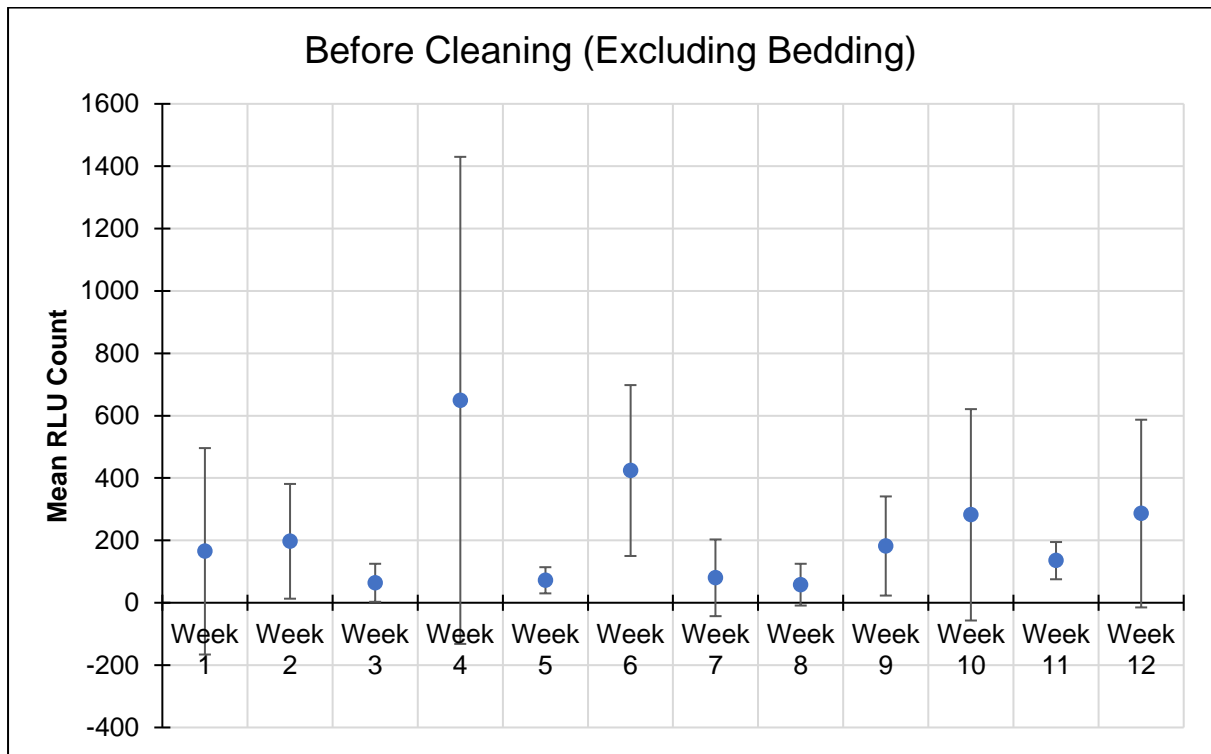
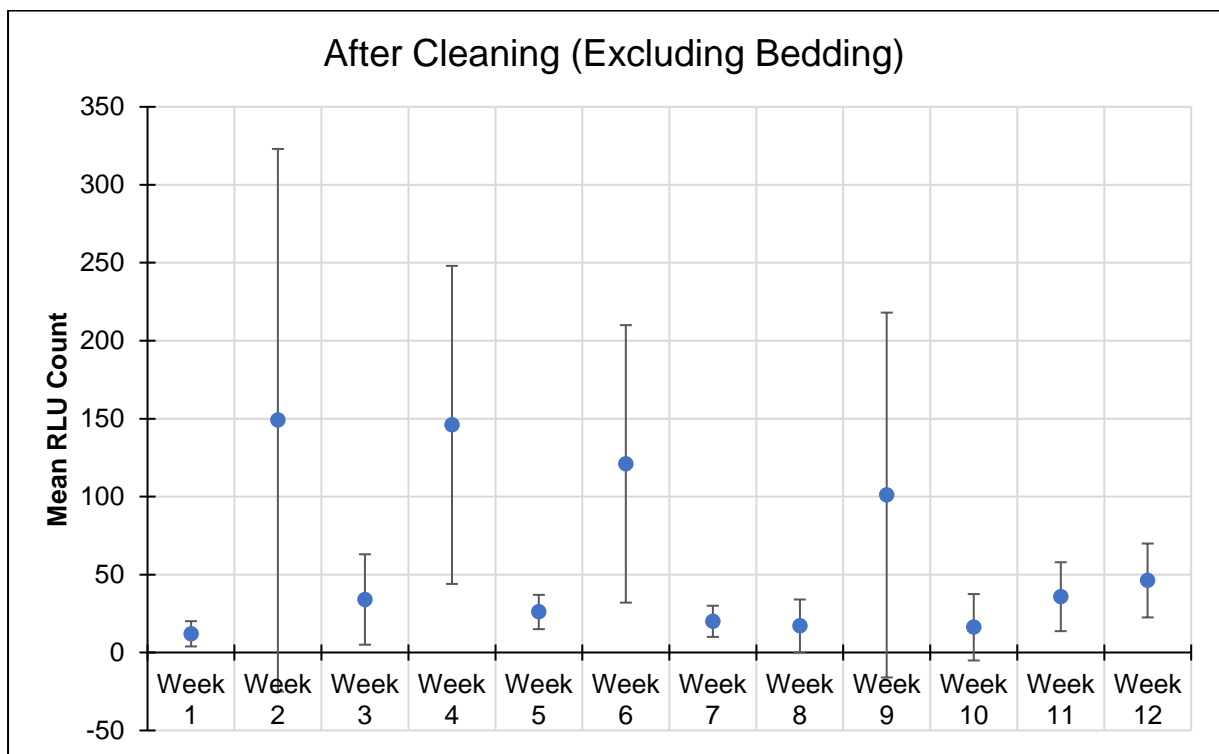
Appendix 6: Mean RLU count with standard deviation error bars (NSL, excluding bedding).

3. When excluding bedding, the average RLU before cleaning was relatively consistent (see Appendix 6). However, the average after cleaning followed a downward trend over the 12-week period indicating that cleaning practices became more rigorous.
